Australian Quarantine and Inspection Service

# COMPACTORS

The following cleaning/inspection guide has been segmented to facilitate the process. The segmentation is as follows:

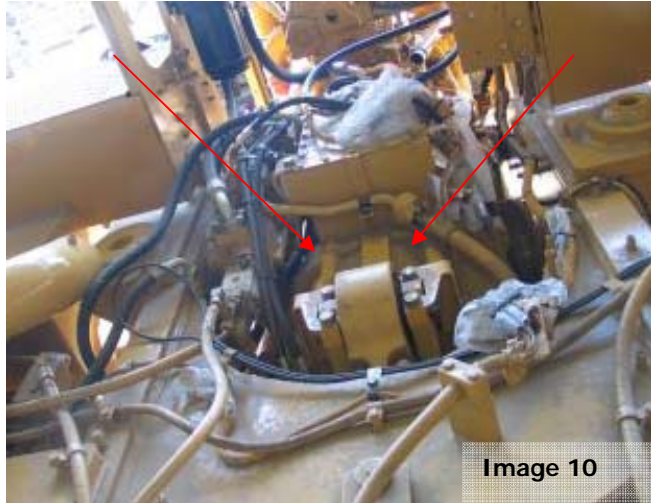
Image 10

A rare sight as the cabin has been removed from the Compactor. The top of the block directly under the cabin is one of the most difficult areas to clean and inspect. The bell housing (red arrows) with the undulating surface can harbour contamination.

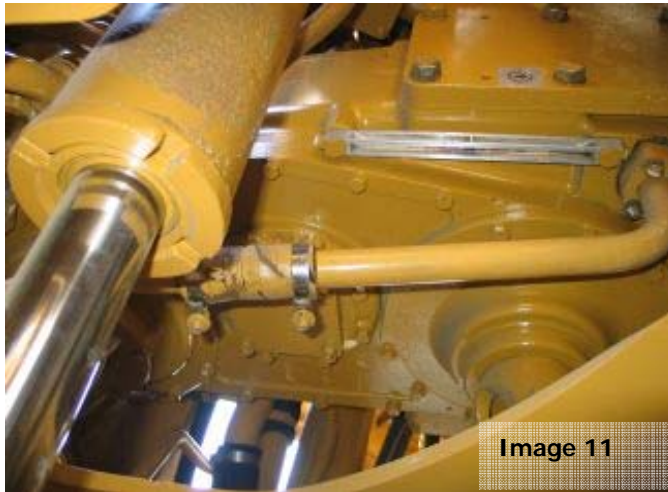
Image 11

The front of the engine as seen from the pivot point. This area contains a myriad of ledges, hydraulic hoses and countersunk holes that all require thorough cleaning and inspection.

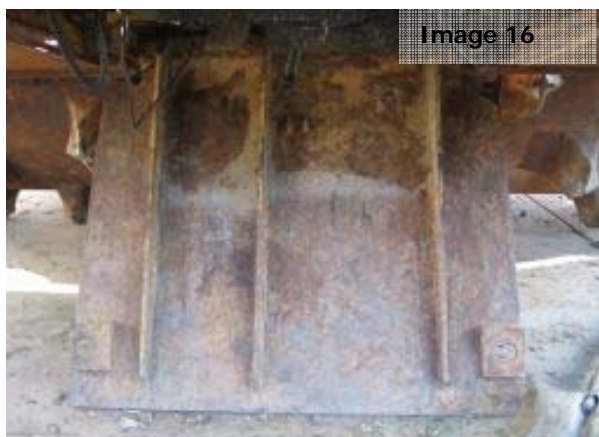
**Image 16:**

One of the 'dropped' belly plates from under the Compactor. This one has no internal or external gussets, however all belly plates must be removed to facilitate cleaning, flushing and inspection.

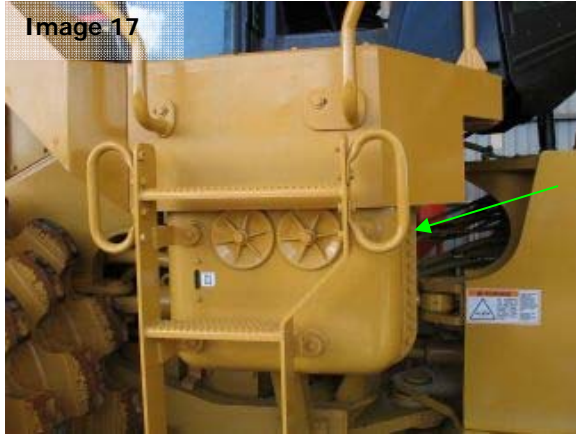
**Image 17:**  
The oil tank under the cabin. The topside and rear of the oil tank is the most difficult to access.

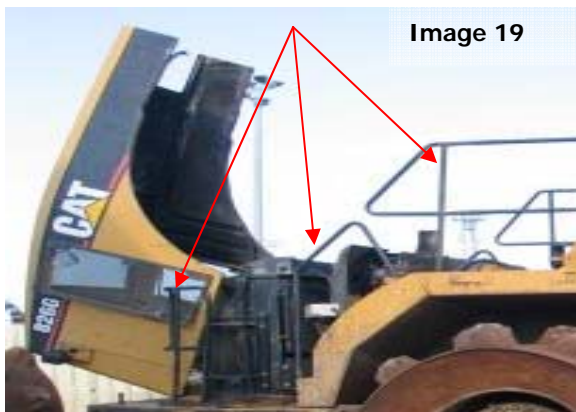
**Image 19:**  
Some engine covers may tilt rearwards as illustrated, exposing the topside of the engine block. The engine covers must be checked for hollow rails and flushed if present. Check all handrails (red arrows) for open ends or drainage holes that can be flushed.

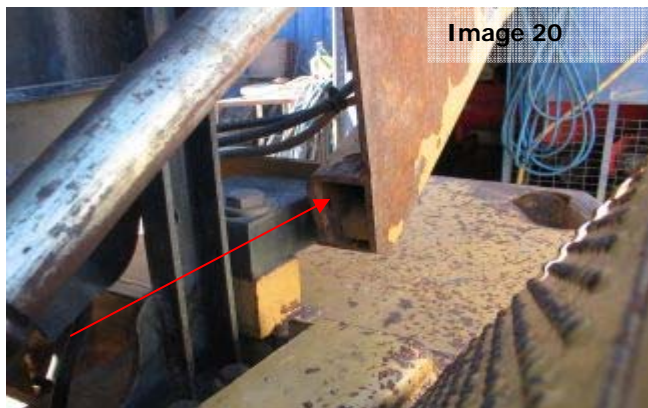
**Image 20:**  
An illustration of a hollow channel in the engine cover (red arrow) of the Compactor. This will require flushing to verify cleanliness.

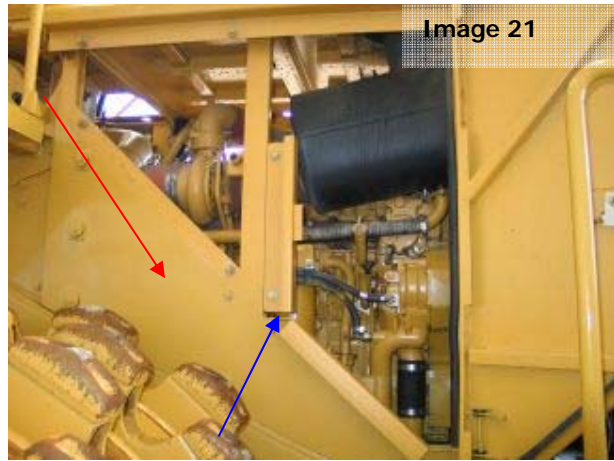
**Image 21:**  
A fixed Compactor engine housing will non-affixed panels (red arrow) and hollow framework (blue arrow).

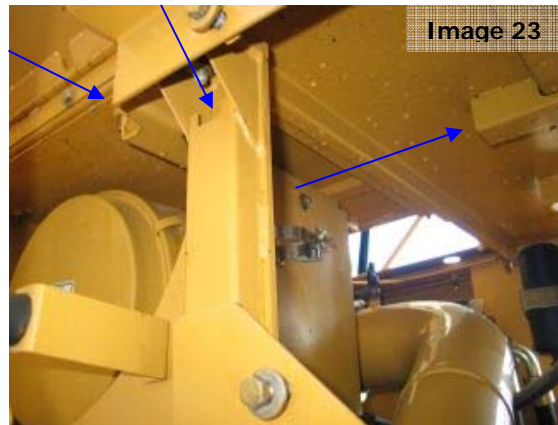
**Image 23:**  
Further illustrations of the hollow support framework that may be located under engine cover covers.

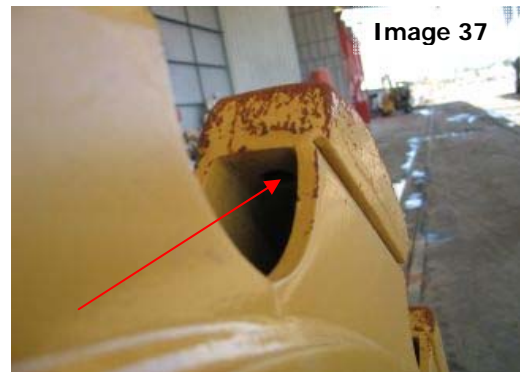
**Image 37:**

The underside of the boot on this style of compactor. Although not easily seen, there is a hole on the underside (where red arrow is highlighting) and these must all be flushed to verify cleanliness.

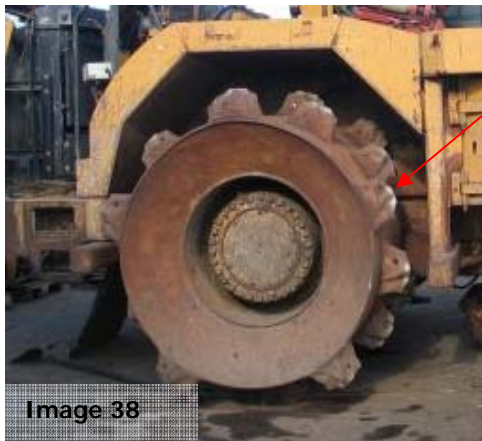
**Image 38:**

Another example of some of the styles of boots that may be found on compactors.

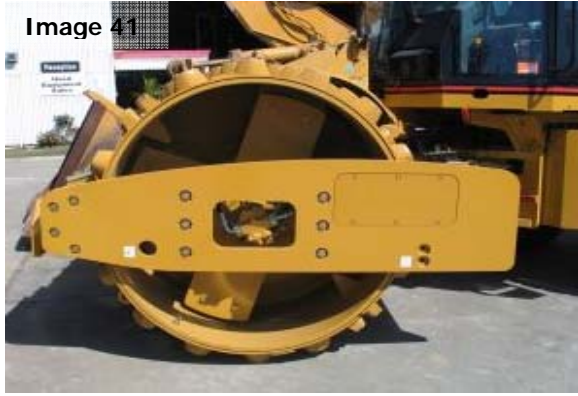
**Image 41:**

Another example of some of the styles of boots that may be found on compactors. The boots illustrated in this shot are spot welded onto a semi-circular drum that is fitted to a roller wheel.

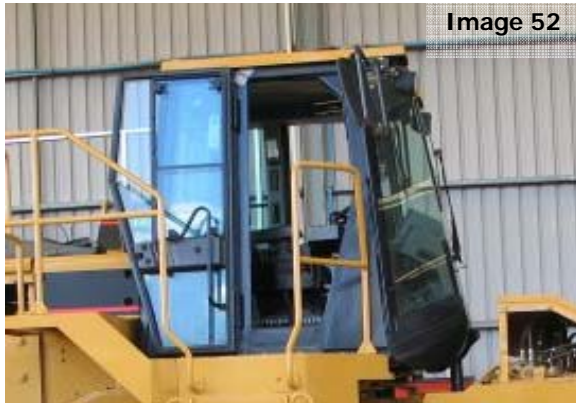
Image 52

**Image 52:**  
The side view of a typical Compactor cabin.

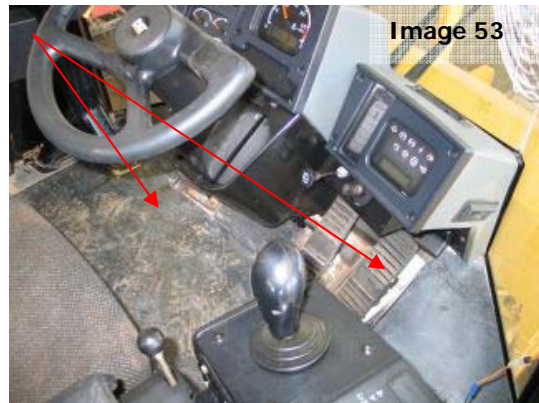
Image 53

**Image 53:**  
The inside of the cabin. All rubber matting and pedal covers (red arrows) is to be removed and cleaned.

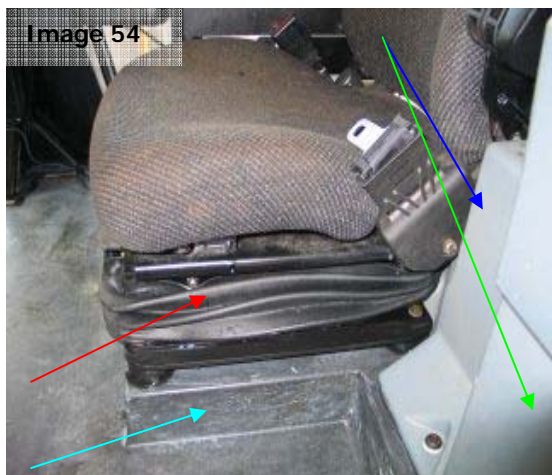
Image 54

**Image 54:**  
The rubber shroud under the seat must be internally and externally cleaned and inspected. Verify behind and inside all cabin wall linings (green arrow) and storage compartments (blue arrow) are free of contamination. On some models the air-conditioning unit is in the box section below the seat (aqua arrow) and access for cleaning and inspection will require that the seat is removed.

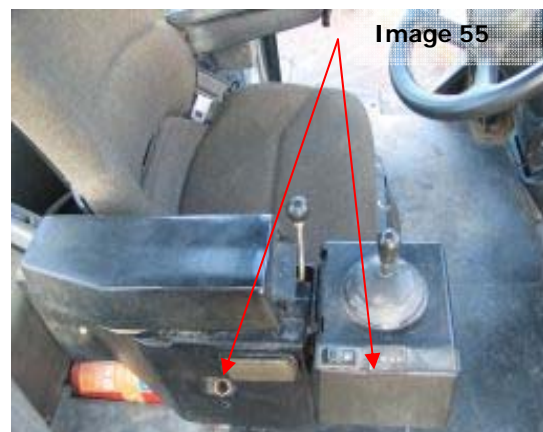
Image 55

**Image 55:**  
Access will be required to the joystick control panels to verify internal cleanliness.

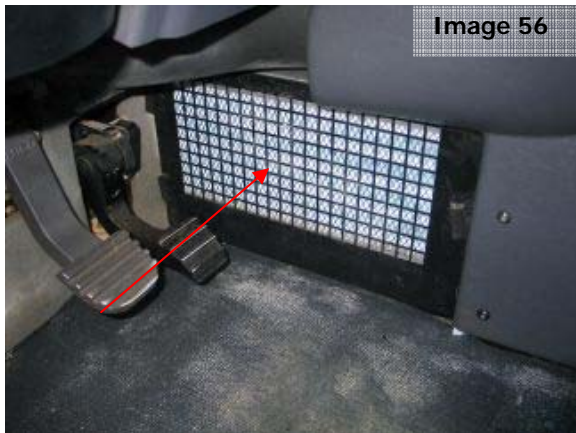
**Image 56:** Remove the air-filter cover (red arrow) and verify the cleanliness of the filter (pressurised air).

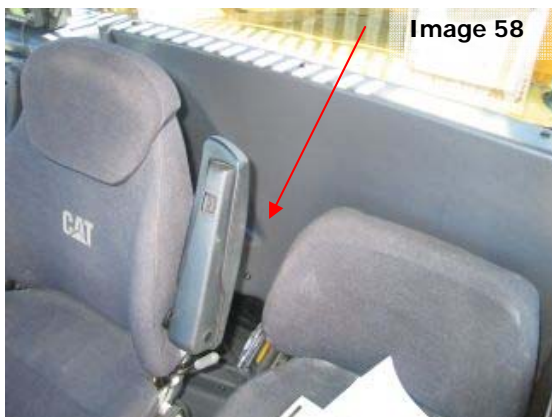
**Image 58:** Verify behind all internal cabin wall linings is free of contamination.

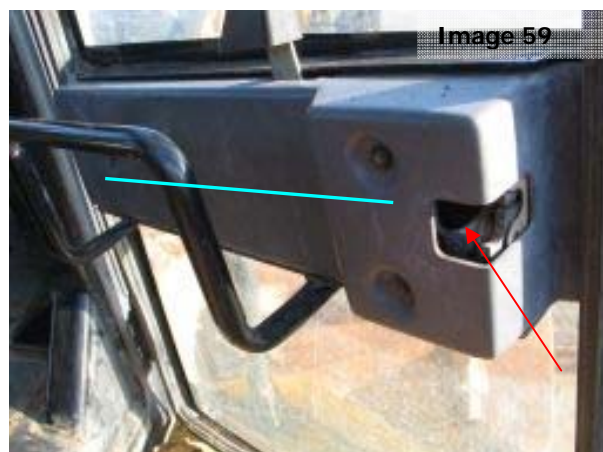
**Image 59:** The door latches are hollow structures and verification of internal cleanliness is required.

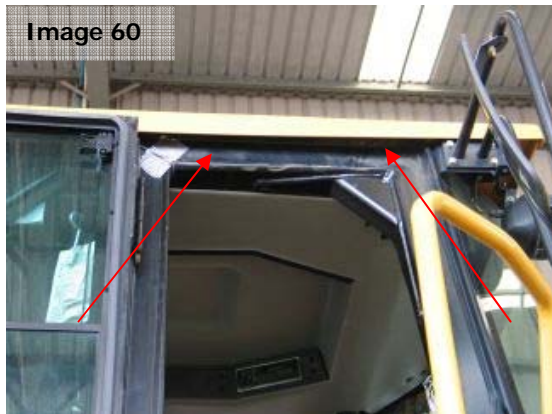
**Image 60:**  
On some models a small recess can be found between the cabin roof and the Roll Over Protection System (ROPS).

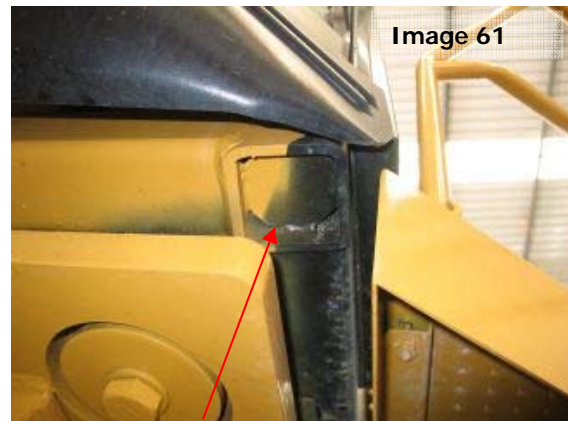
**Image 61:**  
Underneath the cabin, the framework may be open-ended as illustrated (small triangular corners missing) and will require flushing to verify cleanliness.

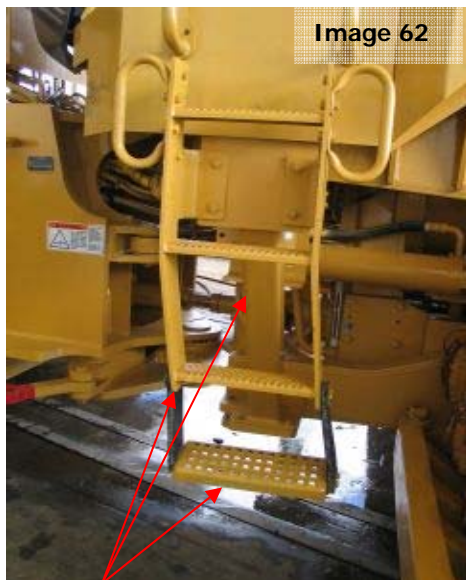
**Image 62:**  
Check all footsteps for cleanliness (including underside).

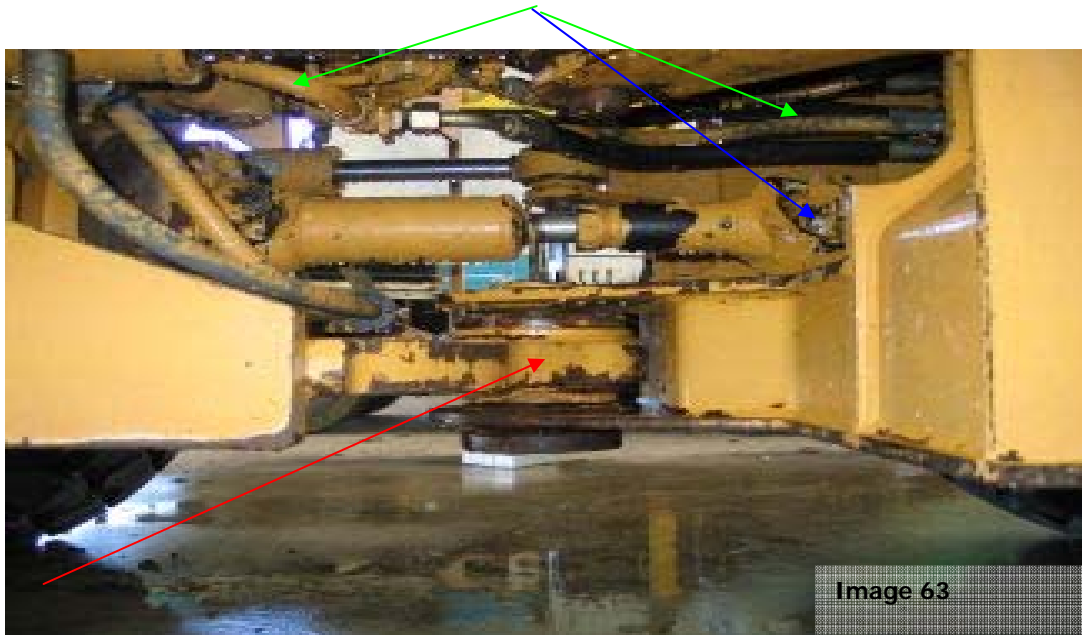
**Image 63:**

The bottom pivot-point (red arrow) as generally seen on Wheel Loaders. This area is signified by several pivot points (above), universal joints (blue arrow) and a myriad of hydraulic hoses (green arrows), all requiring thorough cleaning and inspection.

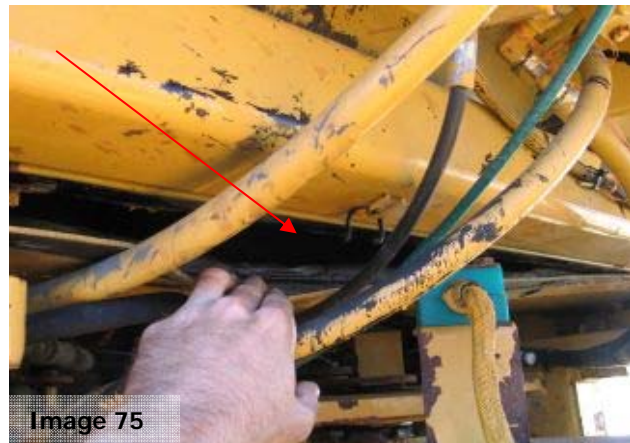
### Images 74 & 75:

On some models of Wheel Loaders, under the cabin may be a false floor (red arrow). These are reasonably common and worth illustrating as this area can harbour a significant amount of contamination. The false floors can be made from hard rubber or compressed fibreboard and can be unbolted to allow access for cleaning and inspection.

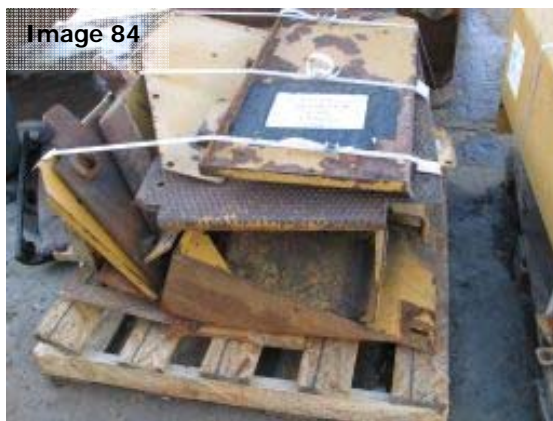
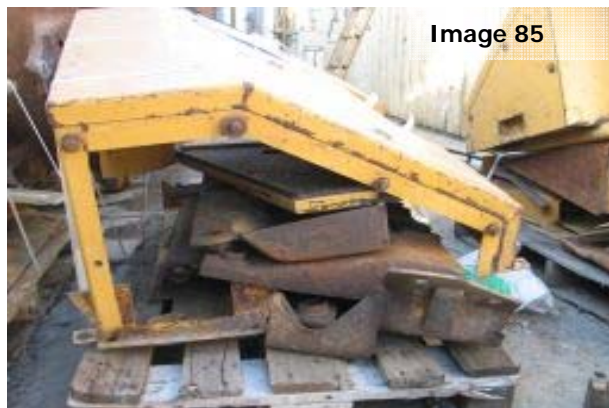
**Images 84 & 85:**  
Examples of the amount of dismantling required to facilitate cleaning and inspection.
