Australian Quarantine and Inspection Service

# MOTOR GRADERS

The following cleaning/inspection guide has been segmented to facilitate the process.  
The segmentation is as follows:

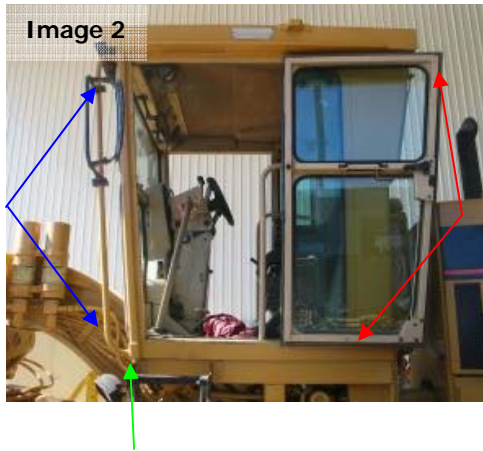
**Image 2:** A typical view of a Grader cabin from the side. Cabin door rubbers (red arrows) can be contaminated and are therefore an area of concern to AQIS. The green arrow highlights the hollow cabin framework, which will be highlighted later.

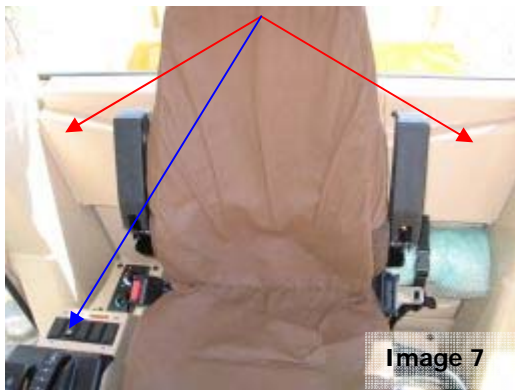
Image 7

**Image 7:** The internal wall lining behind the seat (red arrows) must be removed, allowing access for cleaning and inspection. Access will be required to verify the internal cleanliness of the joystick control panel (blue arrow).

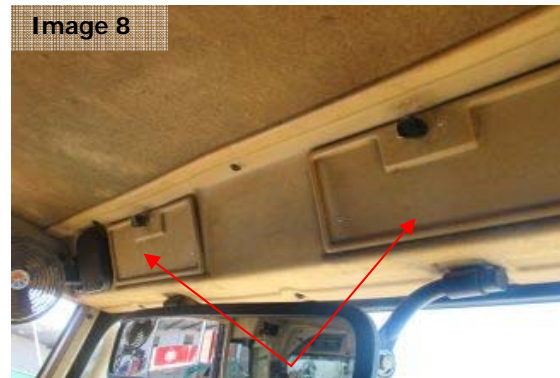
Image 8

**Image 8:** Check overhead storage compartments (red arrows) are free of contamination.

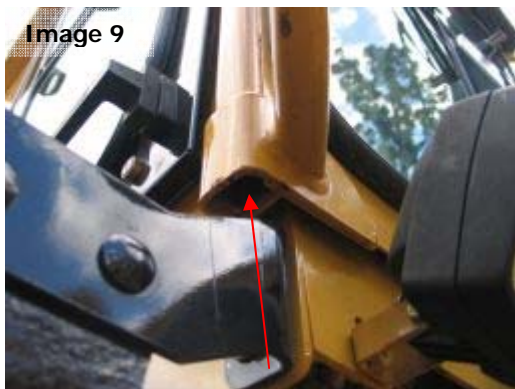
Image 9

**Image 9:** Check the external cabin framework for hollow channels as illustrated. If open-ended (red arrow), then these will require flushing to verify cleanliness.

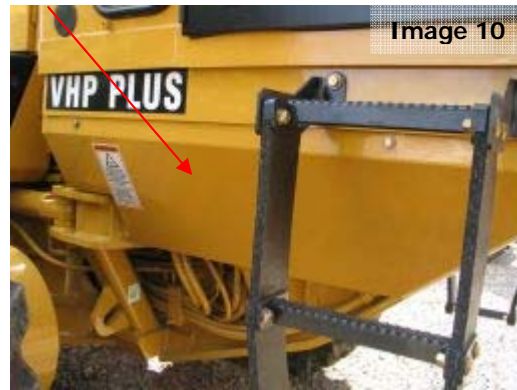
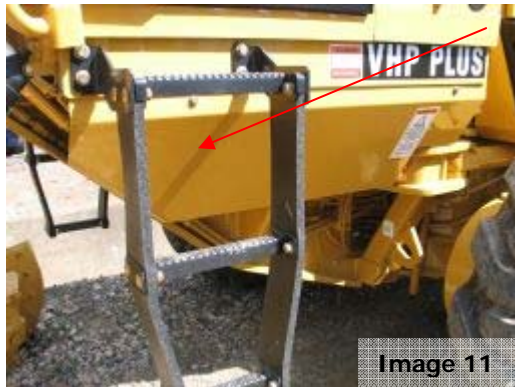
**Images 10 & 11:**

The protective shrouds just below the cabin need to be removed to facilitate the cleaning and inspection process.

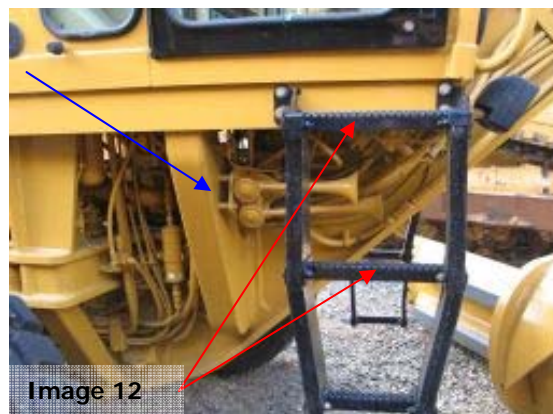
**Image 12:**

Removing the non-affixed panels removed from below the cabin will facilitate the cleaning and inspection process. The green arrow again highlights the open-ended cabin framework. Check all ladder steps (red arrows) are clean.

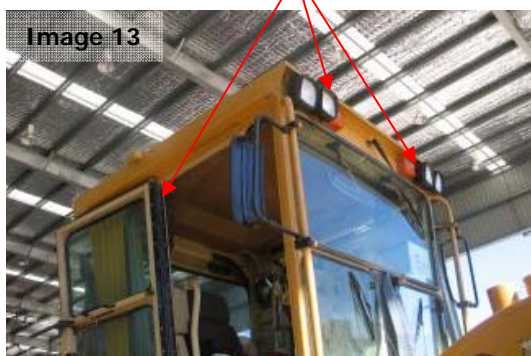
**Image 13:**

All lights (red arrows) must be checked and as previously stated, the door rubbers maybe contaminated and of concern to AQIS.

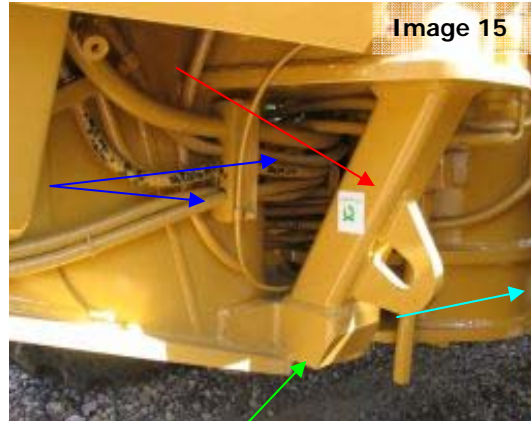
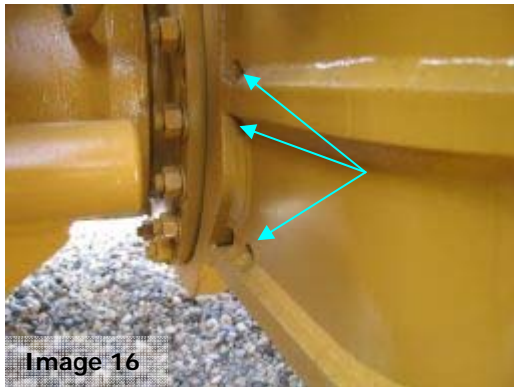
**Images 14 & 15:**

Below the cabin and behind the pivot point is a myriad of channels and hydraulic hoses (blue arrows), all requiring thorough cleaning and inspection. The red arrows highlight channels that may have drainage holes on the base (green arrows). The aqua arrows allude to drainage holes at the rear that will be illustrated next.

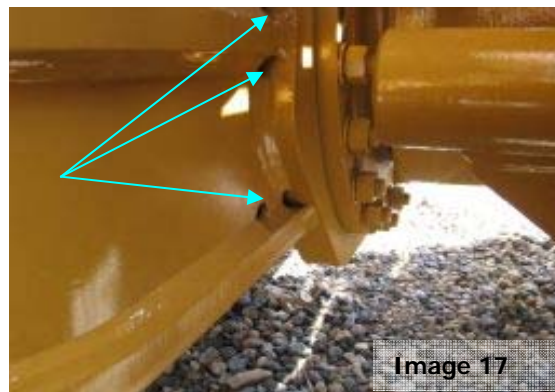
**Images 16 & 17:**

Illustrates the drainage holes located behind the myriad of hydraulic hoses and pivot area, directly below the cabin.

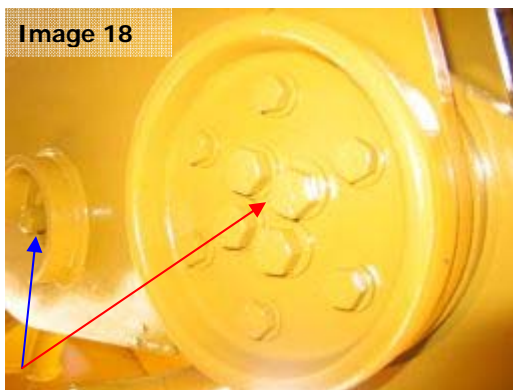
**Image 18:**

The bottom pivot plate must be cleaned and free of all contamination.

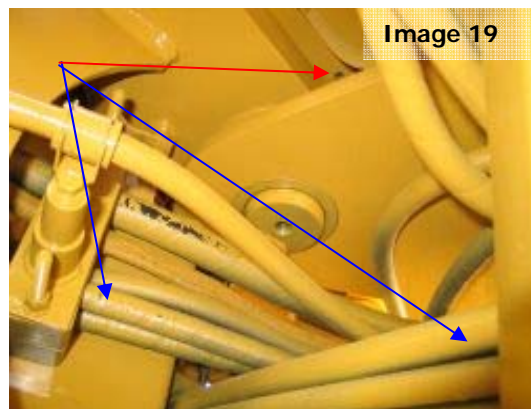
**Image 19:**

The top pivot point below the cabin floor. This area must be thoroughly cleaned, including all hydraulic hoses (blue arrows) and ledges (red arrow).

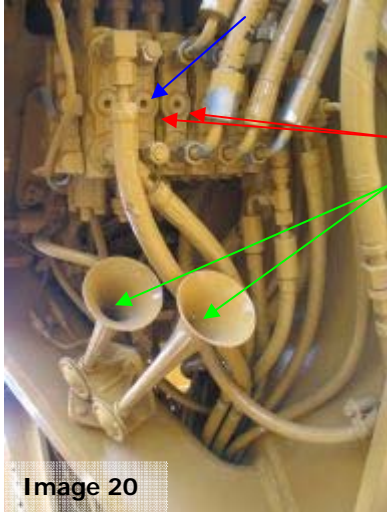
**Image 20:** A closer view of the myriad of hydraulics under the cabin. Each hose must be thoroughly cleaned and inspected. Ensure in between each coupling (red arrow) and countersunk hole (blue arrow) is clean and free of contamination. Wasp nests have been found inside horns (green arrow), internal verification is required.

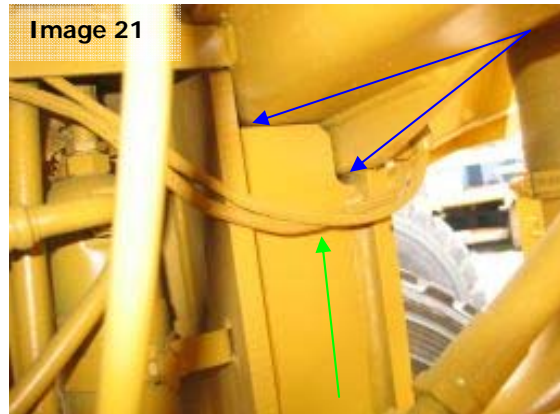
**Image 21:** The green arrow highlights one of the vertical support channels under the cabin. As this channel is not sealed (blue arrows), in this instance it will require flushing to verify cleanliness.

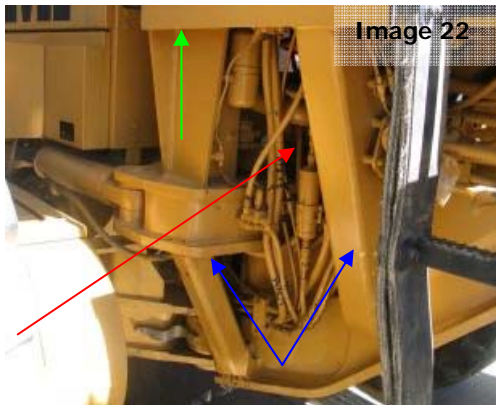
**Image 22:** Check all under cabin support rails for drainage holes or openings. As the green arrow highlights and the next illustration illustrates, is not all holes are on the bottom of the channels. Check all surfaces of other support channels (blue arrows) for openings that will require flushing, if present. The myriad of hydraulic hoses in this area requires thorough cleaning and inspection.

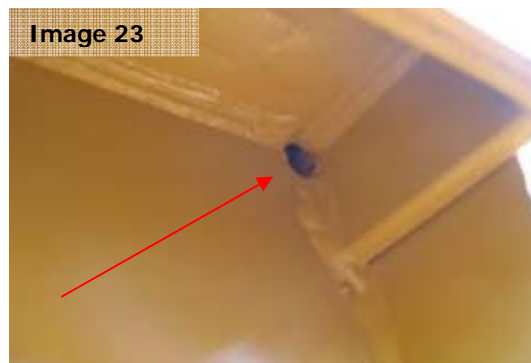
**Image 23:** The opening at the top of the channel (red arrow) as highlighted by the green arrow in the last illustration. These areas must be flushed to verify cleanliness.

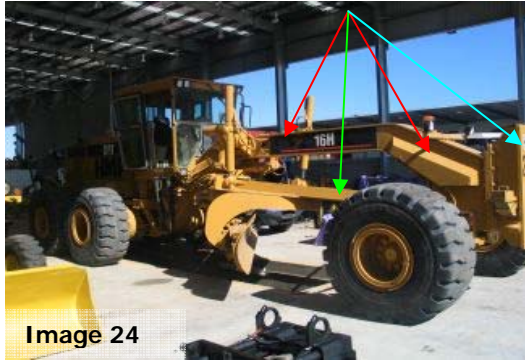
**Image 24:**  
The Gooseneck (red arrows), circle arms (green arrow) and front end (Aqua arrow) of the Grader.

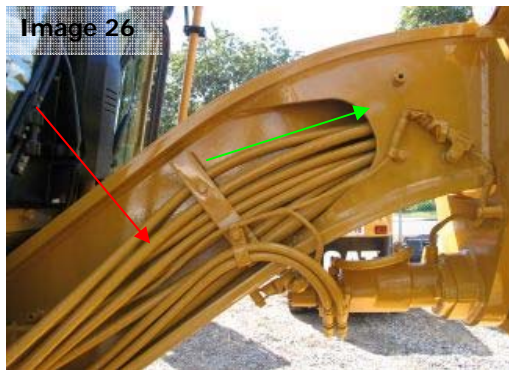
**Images 26 & 27:**  
The rear of the Gooseneck, just in front of the cabin. All non-affixed panelling has been removed to allow cleaning of all hydraulic hoses and inspection. The hollow area highlighted by the direction of the green arrows is to be flushed to verify cleanliness.

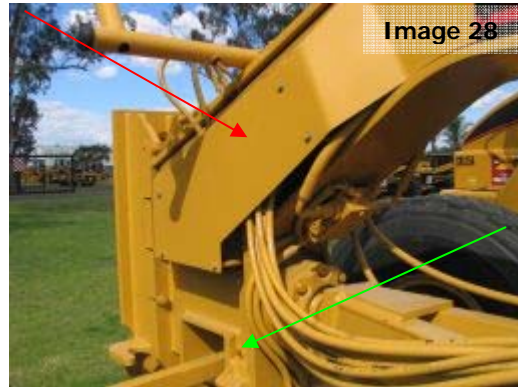
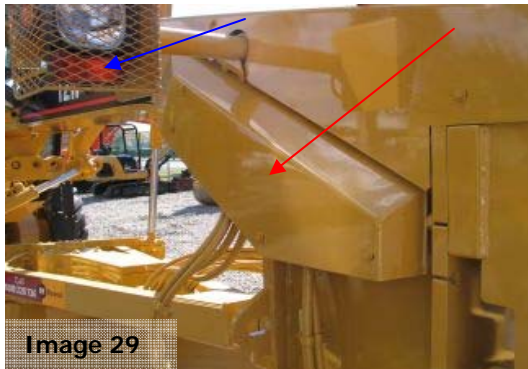
**Images 28 & 29:**

On the front end or nose, a variety of non-affixed panelling can be found. All must be removed to facilitate the cleaning and inspection process. The green arrow highlights the Gooseneck drainage hole, which will be highlighted later. Check the internal of all light fittings (blue arrow) for cleanliness.

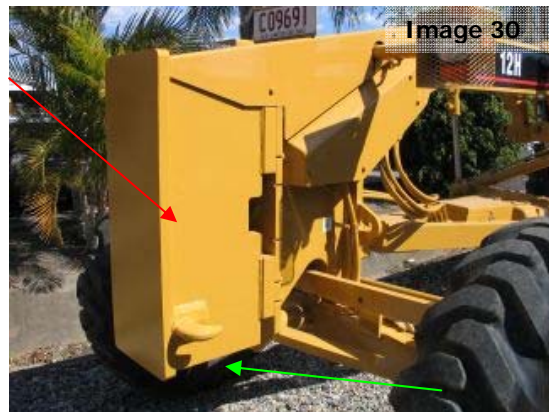
**Image 30:**

The front counterweight (red arrow) Check all surfaces for cleanliness and for drainage holes on the underside (green arrow). Flush if drainage holes are present.

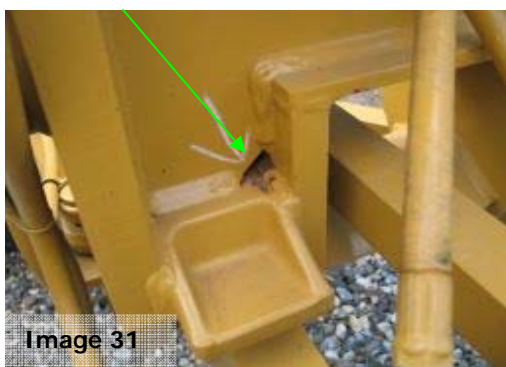
**Image 31:**

The drainage hole (green arrow) at the front of the Gooseneck as mentioned earlier.

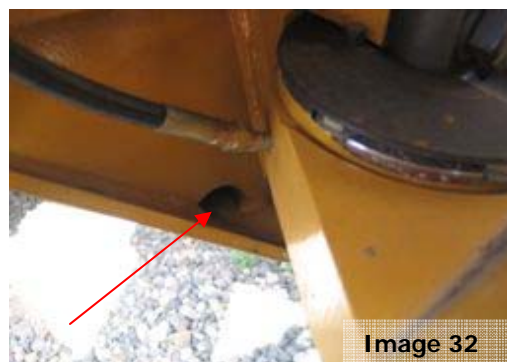
**Image 32:**

A drainage hole (red arrow) at the bottom of the counterweight. This will require flushing to verify cleanliness.

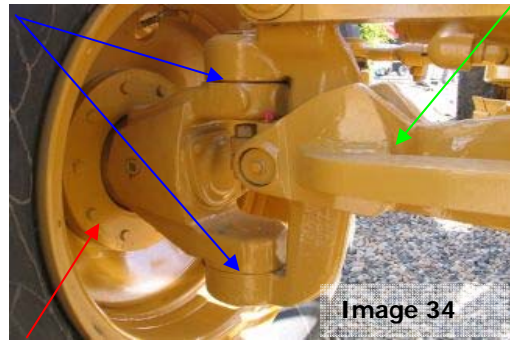
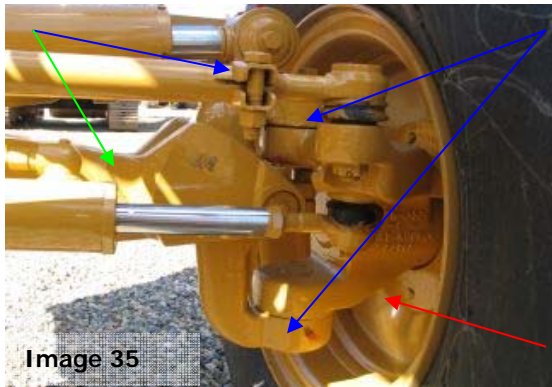
**Images 34 & 35:**

The front rims (red arrows), axels (green arrows) and hydraulic rams and pivot points (blue arrows). All contaminated grease must be removed from these areas.

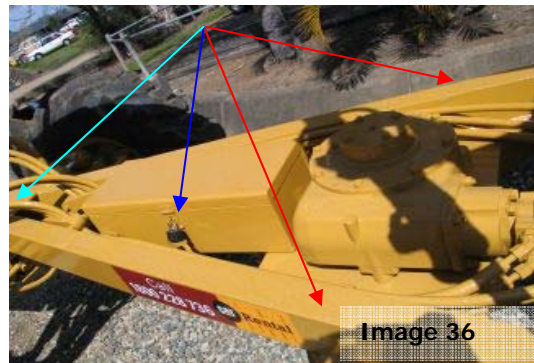
**Image 36:**

The circle support arms (red arrows) under the Gooseneck. Check these arms for cracks, splits, and evidence of repair or drainage holes (aqua arrow) as illustrated next.

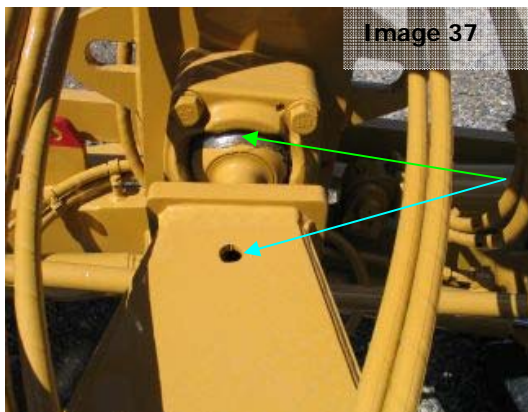
**Image 37:**

The drainage hole (aqua arrow) at the point where the two arms meet at the front end. There maybe further drainage holes on the underside. If these arms have openings as illustrated, they must be flushed to verify cleanliness. Remove all contents of the toolbox (blue arrow) and clean internal surfaces.

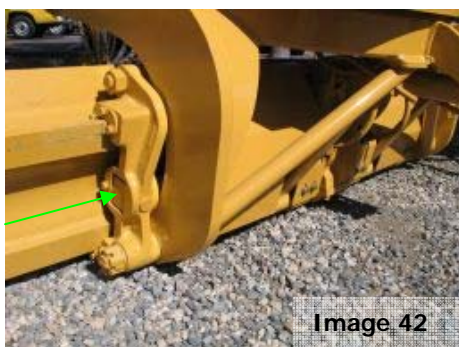
**Image 42:**

As blades can be adjusted along a slide, flush through the small recesses (green arrow) to verify cleanliness.

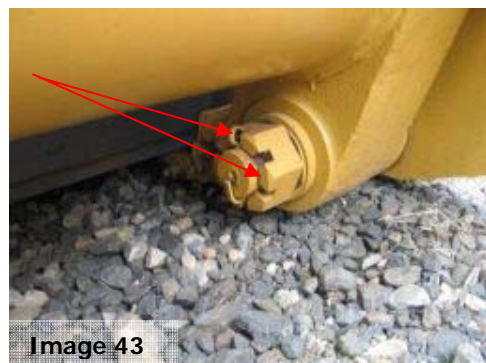
**Image 43:**

Clean and inspect all countersunk recesses (red arrows) on the nuts.

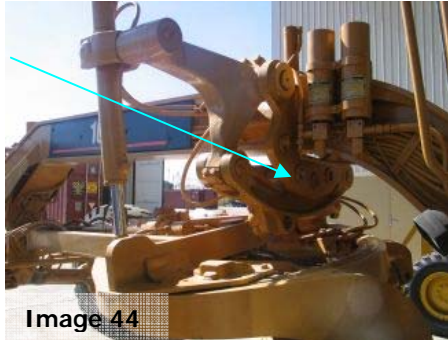
**Image 44:**

Above the Circle is the Blade Pitch Adjuster. This configuration comprises of hydraulic rams, pivot points

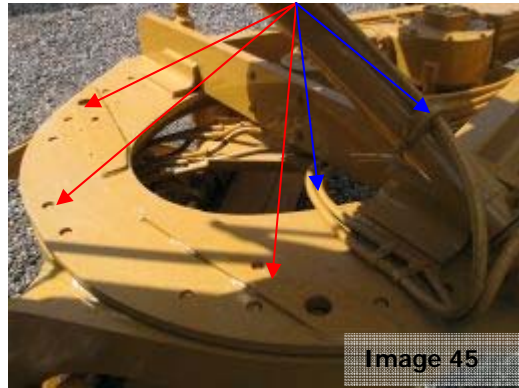
**Image 45:**

All surfaces on the topside, including countersunk holes (red arrows) must be free of all contamination. All hydraulic hoses (blue arrows) must be free of contamination.

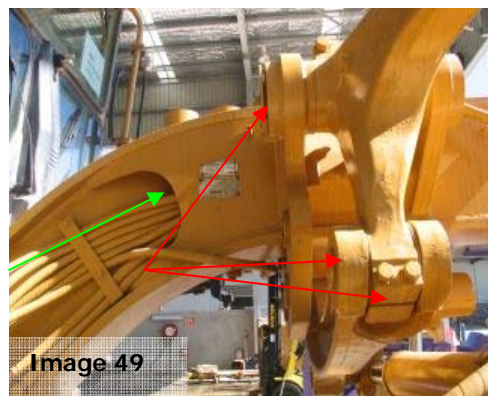
**Image 49**

A side on view of the blade pitch adjuster. The green arrow highlights the hollow cavity in the Gooseneck, which requires flushing to verify cleanliness. The red arrows highlight the pivot points where all contaminated grease must be removed.

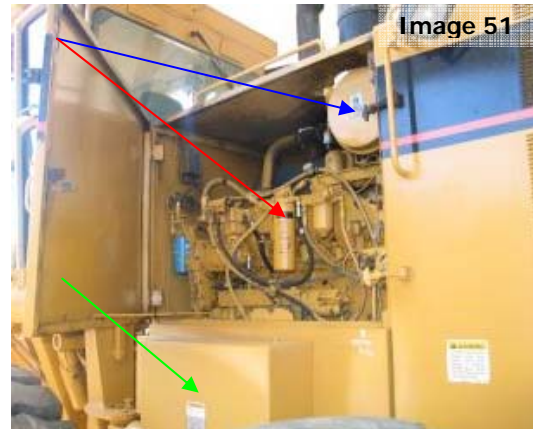
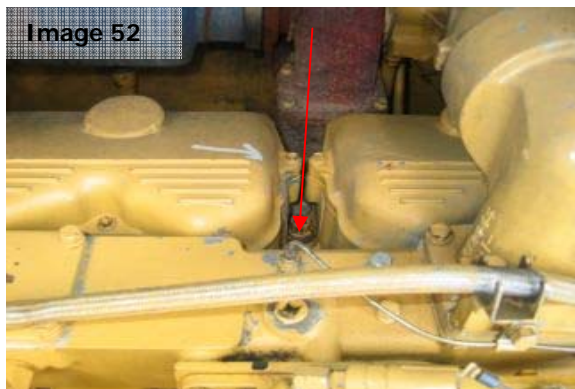
**Images 50 & 51:**

The sides of the Grader engine bay. All surfaces of the block, around all oil filters and hoses must be thoroughly cleaned and inspected. The air-filters must be removed and verified clean. On some models, the battery box is mounted on the side (green arrow).

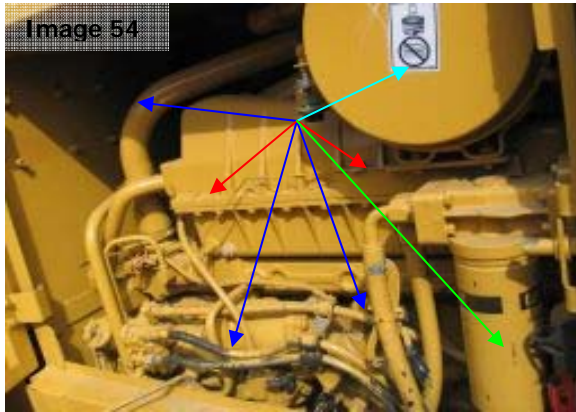
**Image 54:** Another example of the side of the engine block of a Grader. All ledges (red arrows), hoses (blue arrows), filters (green arrow) and air-filters must be thoroughly cleaned and inspected.

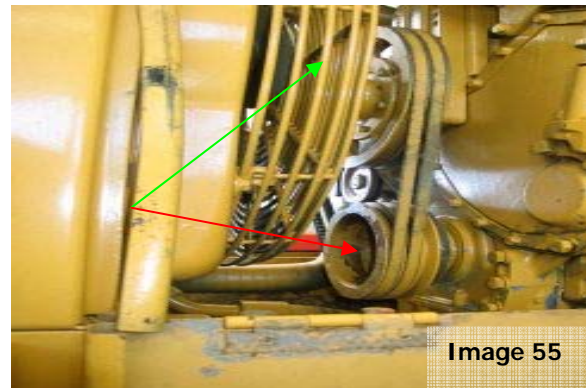
**Image 55:** The harmonic balancer or flywheel (red arrow) at the front of the block. This area is concave and must be cleaned thoroughly. The inside radiator grill (green arrow) must be removed to allow cleaning and inspection access to the bottom of the radiator shroud.

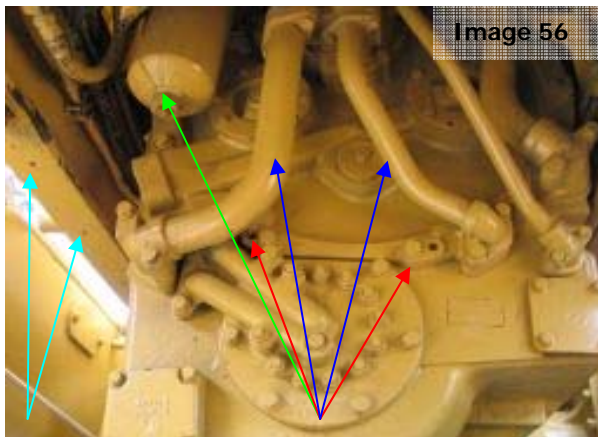
**Image 56:** The underside of the block, visible once the belly plates have been removed. All countersunk holes (red arrows), hoses (blue arrows) and filters (green arrow) must be thoroughly cleaned and inspected. The aqua arrows highlight the hollow chassis rails that will be illustrated later.

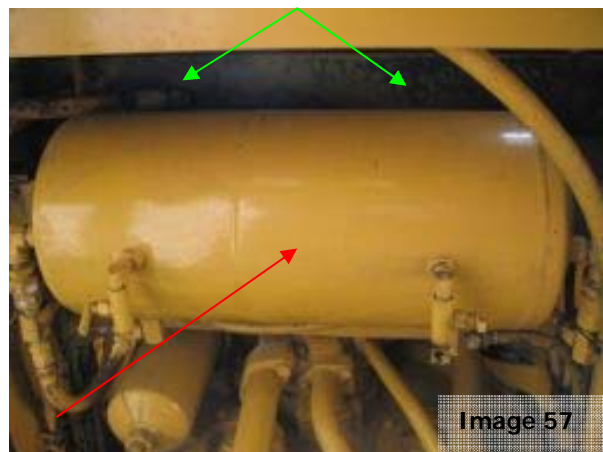
**Image 57:** An air tank (red arrow) can sometimes be found at the rear of the Grader. Thorough cleaning, particularly the topside (green arrows) is essential.

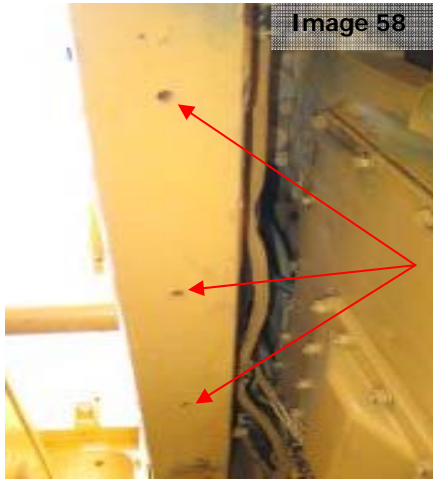
**Image 58:**

Once the belly plates have been removed, the empty bolt holes (red arrows) allow flushing access to the chassis rails either side of the engine block. These rails must be flushed in the presence of the inspecting officer to verify cleanliness.

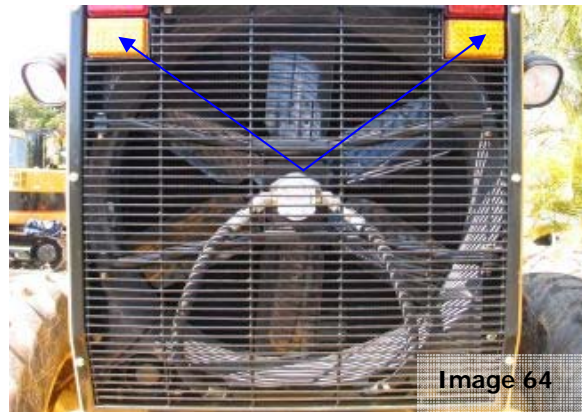
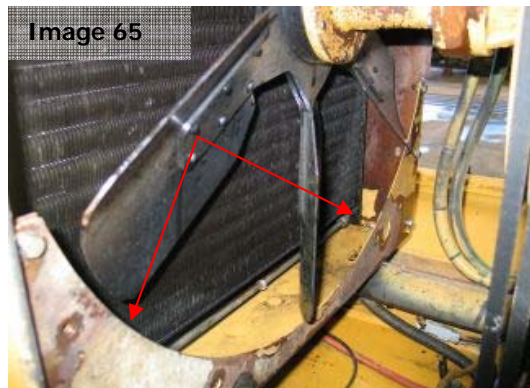
The rear radiator grill on back of the Grader. This grill must be removed to allow cleaning and inspection access to the radiator core. All light fittings (blue arrows) must be verified internally clean.

The radiator grill removed, allowing cleaning and inspection access to the inside of the radiator shroud.

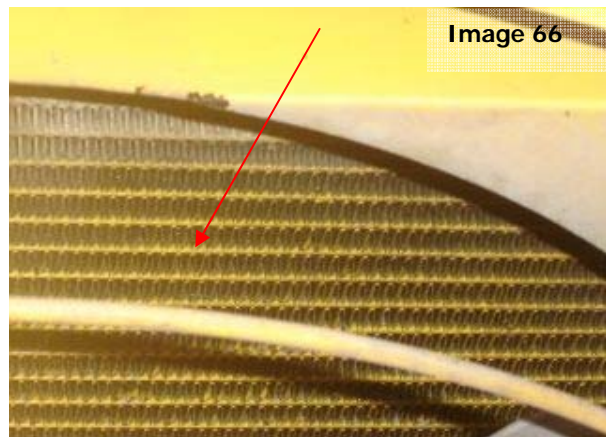
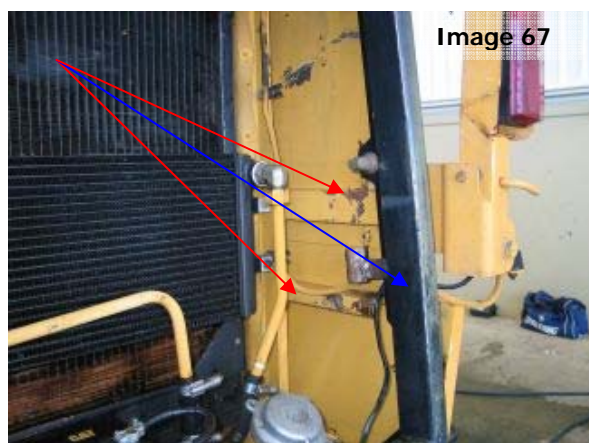
The radiator core (fins) that require flushing to remove all contaminants and to verify cleanliness.

This picture illustrates the right hand side of the engine cover near the radiator. The two red arrows highlight open-ended channels that will require flushing to verify cleanliness. Check the outside framework (blue arrow) for open ends or drainage holes. If present, flush to verify clean.

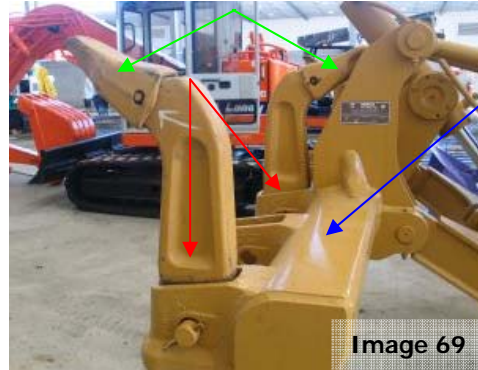
**Image 68:**

The Ripper Cradle (red arrows) and Tynes. All cutting teeth (green arrows) must be removed for internal cleaning and inspection.

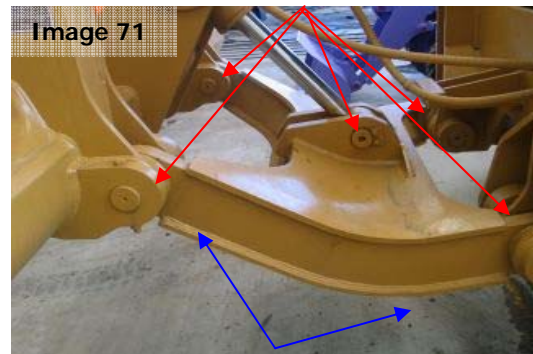
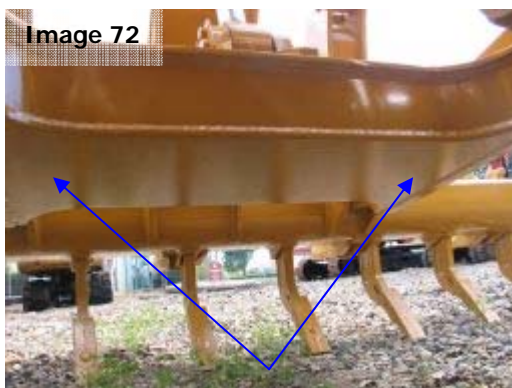
**Images 70 & 71:**

Two examples of ripper cradles. All contaminated grease must be removed from all pivot points (red arrows) and check the ripper cradle surfaces for drainage holes (blue arrows), cracks, splits or any evidence of repair. If breached, it will have to be investigated and verified clean.

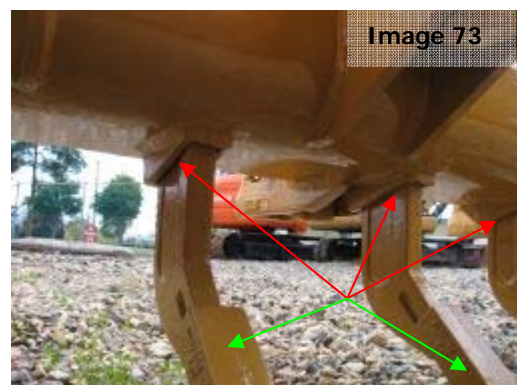
All cutting teeth (green arrows) must be removed for cleaning and internal inspection. Flush through the tyne pockets (red arrows) to verify cleanliness.

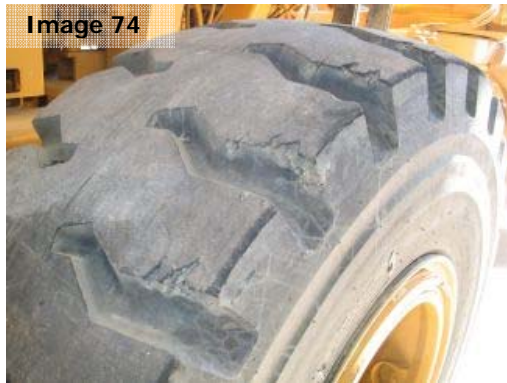
Image 74

Tyres in this condition can be easily cleaned and inspected.

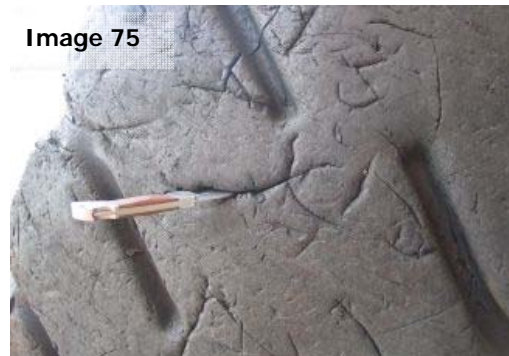
Image 75

All cracks and splits in tyres must be verified that all are free of contamination.

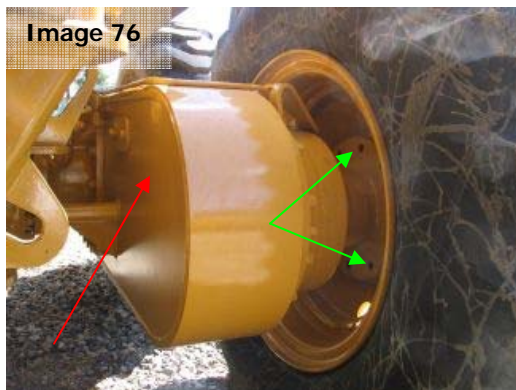
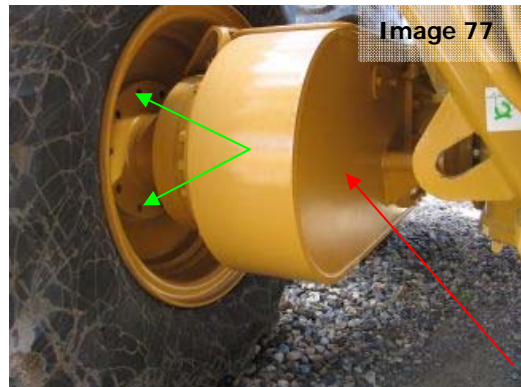
Image 76

The final drive motors are sealed inside these illustrated sections (red arrows) and filled with oil. All countersunk holes (green arrows) inside the rims must be clean and free of all contamination.

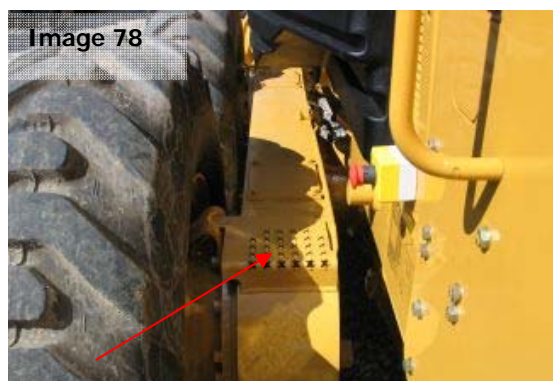
Image 78

Check under each footstep (red arrow) on the final drive motors is clean and free of contamination.

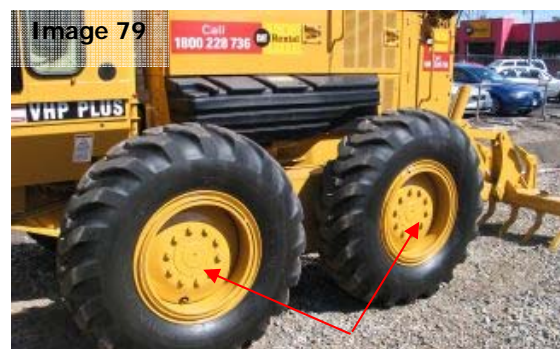
Image 79

All outside rims must be cleaned and free of contamination.

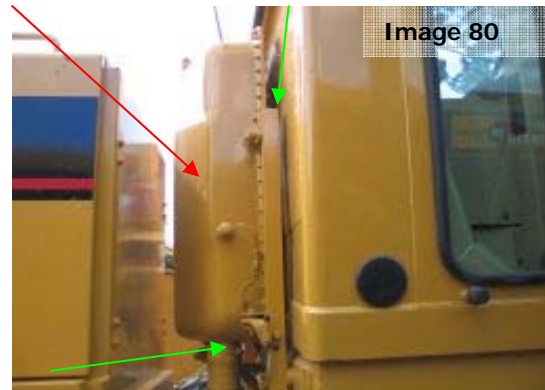
### Image 80:

The oil tanks (red arrow) on Graders are commonly located behind the cabin. All surfaces, particularly the backside and bottom (green arrows) are the hardest to access. The tank can be loosened off to allow access.

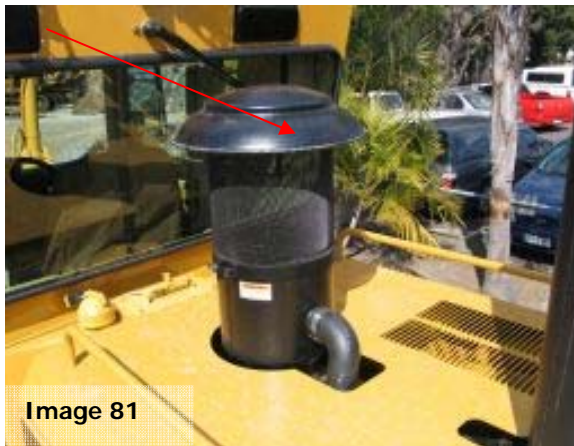
### Image 81:

The top of the air-filter pre-cleaner must be removed for cleaning and inspection access.

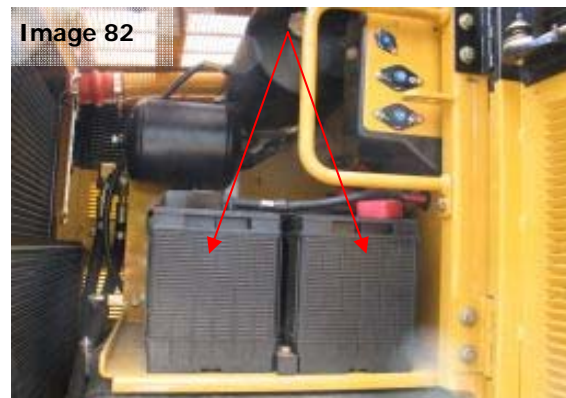
### Image 82:

All batteries (red arrows) must be loosened from tie-down points for cleaning and inspection. All hollow framework (blue arrow) is to be flushed to verify cleanliness.

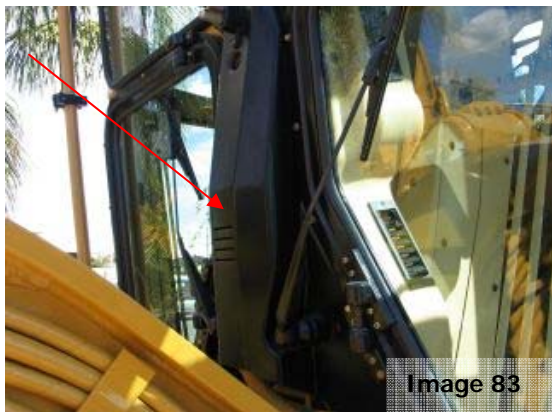
### Image 83:

The windscreen wiper housing (red arrow) will have to be removed to verify internal cleanliness.
